## Spinnaker Ridge *Gig Harbor, WA*

Report #: 24113-12  
Beginning: January 1, 2026  
Expires: December 31, 2026

## RESERVE STUDY Update "With-Site-Visit"

July 28, 2025

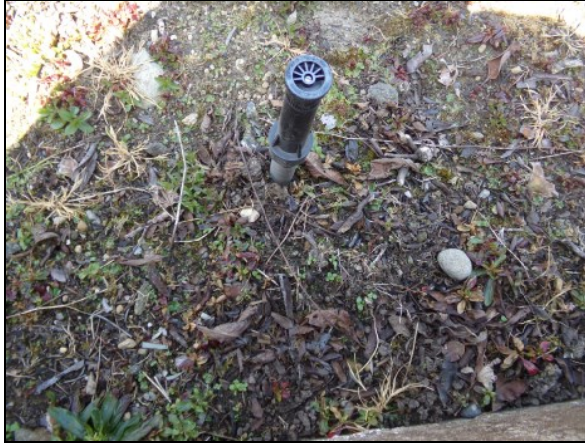
**Comp #: 126 Irrigation Systems - Repair/Replace****Approx Quantity: 1 Extensive systems****Location:** Throughout common area landscaping**Funded?:** No. Annual costs, best handled in operational budget**History:** None known**Comments:** No widespread replacement needs for existing in-ground systems were reported; history of ongoing repairs from general operating funds continues. As routine maintenance, inspect regularly, test system, continue to follow proper winterization and spring start up procedures, spot repair as needed.**Useful Life:****Remaining Life:**

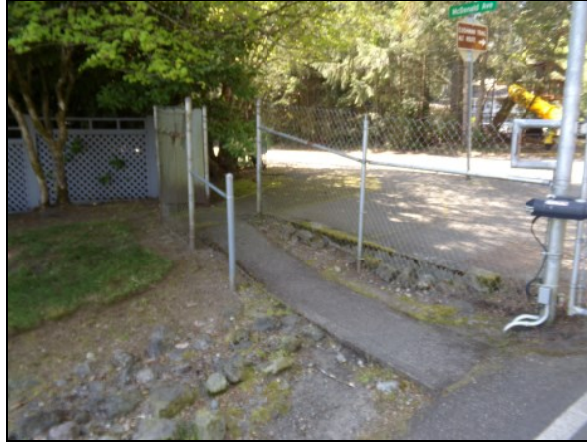
Board representative Steve Feltus indicates this fence will not be replaced at time of any failure - reserve funding removed based upon that stated assumption.

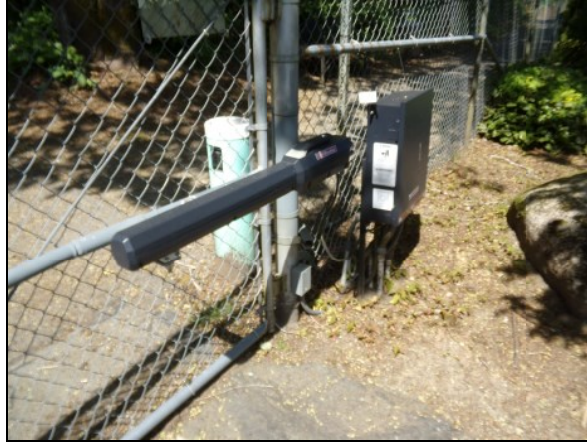
**Comp #: 180 Emergency Gates Operators - Replace****Approx Quantity: 2 each****Location:** West perimeter of community**Funded?:** Yes. Meets National Reserve Study Standards criteria for Reserve Funding**History:** Gate operators were reportedly added in 2004, replaced in 2020 at expense of \$6,800**Comments:** Older chain link gates with general deterioration as expected; cleaning and minor repair from operating budget assumed. Regarding the gate operators that were reportedly added in 2004, then replaced in 2020 at expense of \$6,800, inspect and performance test regularly. Anticipate replacement intervals at extended life cycle utilized below since operators are only used for confidence testing or in emergencies (ice/snow events, etc...). Similar level of current gate/operator replacements factored below; adjust in future reserve study update as conditions merit.**Useful Life:**  
15 years**Remaining Life:**

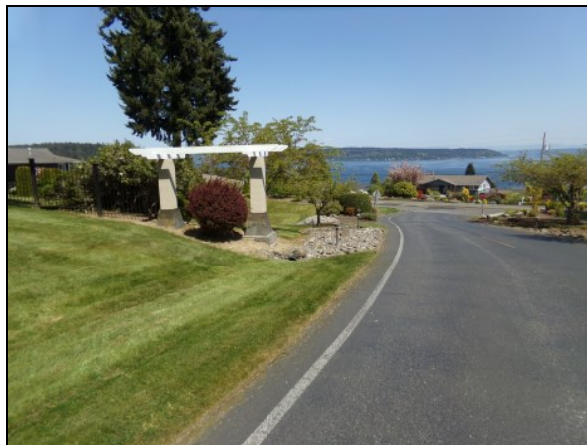
Clean and paint along with other exterior paint projects, no need for separated funding. Assuming ordinary maintenance, plan for significant repair allowance as factored below.

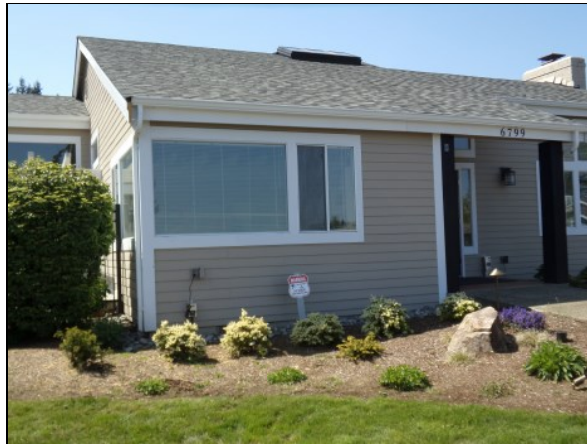
**Comments:** Forensic building inspection is beyond the scope of a Reserve Study. A reserve study is a budget model, limited to visual exterior observation and research. It is outside the scope of our services, and the purpose of a reserve study, to assess the adequacy of the building envelope and structural performance, as many of the key details are typically hidden from view. Any current areas of concern noted from our limited exterior observations and report research, future cycles for repair and replacement, have been stated in the various component field notes throughout this report. Your plans to replace existing old siding, WRB in 2023 but no comprehensive, third party expert evaluation/guidance is known or has been provided for our review. We now recommend regular professional comprehensive inspections by a qualified engineering, architectural, or building envelope consulting firm to evaluate the performance of the Clubhouse building envelope and structural components to inform the long term budget moving forward. The building envelope inspection typically should cover at least the siding/WRB, windows, doors, sealants/caulking/ flashings and roofs. "Budget placeholder" funding factored below; update in future reserve study updates as conditions merit.
