## Spinnaker Ridge *Gig Harbor, WA*

Report #: 24113-12  
Beginning: January 1, 2026  
Expires: December 31, 2026

## RESERVE STUDY Update "With-Site-Visit"

July 28, 2025

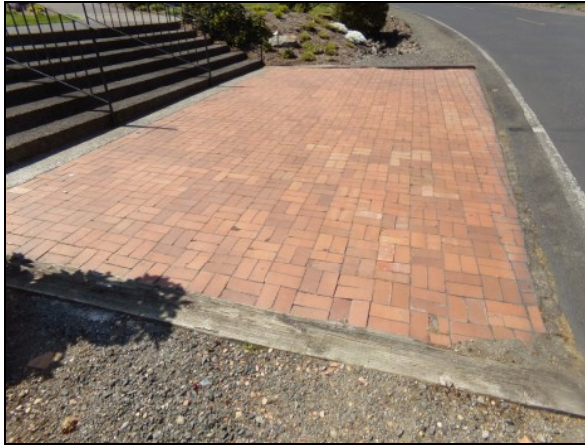
**Comp #:** 102 Concrete/Curb - Repair/Replace

**Comments:** Some local areas with curb damage or surface cracking of HOA concrete were noted.
